FIELD INSPECTION

Project Name:	Mountain Valley Pipeline	Inspector:	Matthew Grant
Inspection Date:	Tuesday, September 25, 2018	Project Contact:	Brian Clauto
Spread: Montgomery County	Spread H	Weather (Wet/Dry/Rain):	Wet

FIELD INSPECTION PHOTO LOG

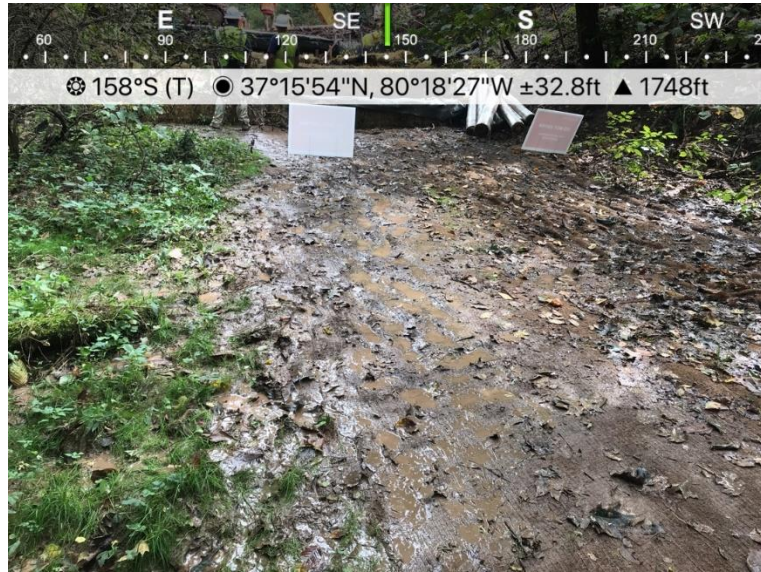
- **Area 1** - MP 227.9 station#12035+19 designated stream SG-40 dewatering structure outlet area was inadequately stabilized and pump around energy dissipater was inadequate. Remove sediment per DEQ approval.

Fig. 1
MP 227.9 St#12035+19 designated stream SG-40 dewatering structure outfall area

Deadline: Immediately

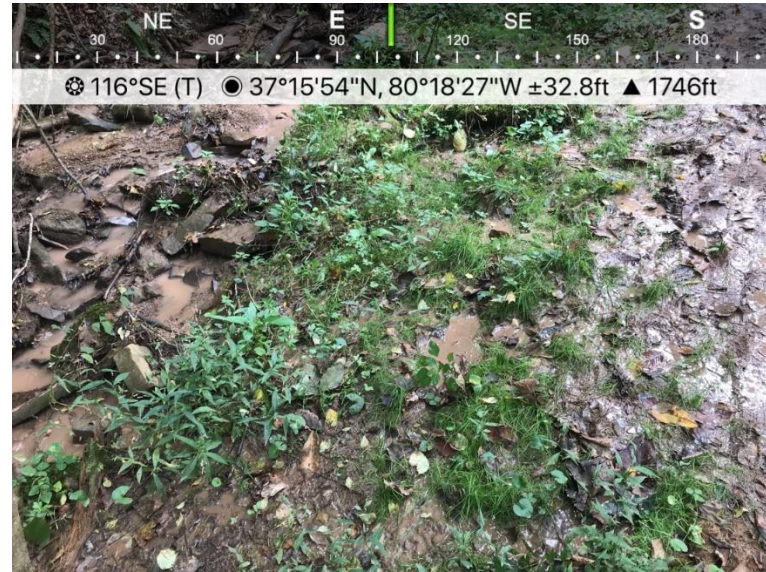
Fig. 2
MP 227.9 St#12035+19 designated stream SG-40 dewatering structure outfall area

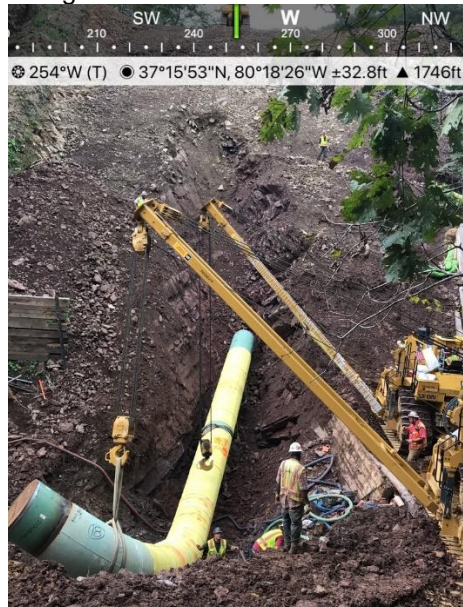
Fig. 3
Designated stream SG-40 trench crossing

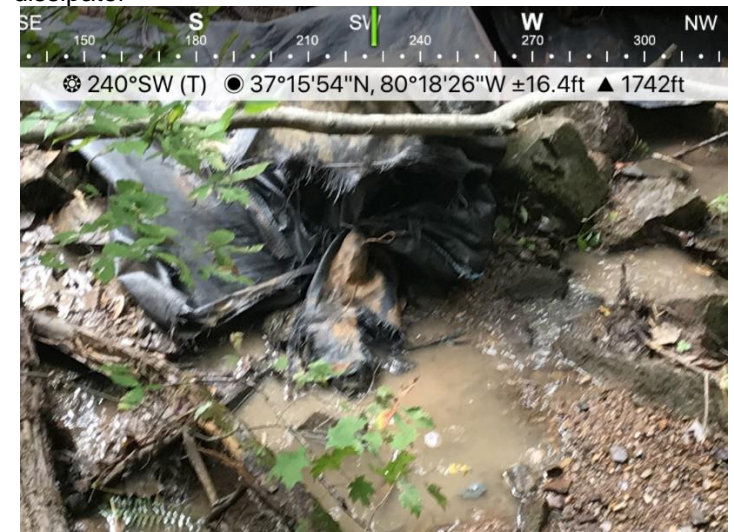
Fig. 4
Designated stream SG-40 inadequate pump around energy dissipater
